Prüfbericht - Nr.: <i>Test Report No.:</i>	IND/BLR/CH/2018/1501R	Seite 1 von 3 <i>Page 1 of 3</i>	
Auftraggeber: <i>Client:</i>	Sunflex Recycling Pvt Ltd Plot No. – 274/4, Shital Estate B/H Satyamev Complex, Opp. Gujrat High Court, S. G. Highway, Sola Ahmedabad, 380060, India		
Gegenstand der Prüfung: <i>Test item:</i>	Rubber Tiles		
Bezeichnung: <i>Identification:</i>	Serien-Nr.: <i>Serial No./ Document Submitted:</i>		
Wareneingangs-Nr.: <i>Receipt No.:</i>	06032018	Eingangsdatum: <i>Date of receipt:</i>	06.03.2018
Order No.:	1803301976	Testing Period:	15.03.2018 to 16.03.2018
Prüfart: <i>Testing location:</i>	TÜV Rheinland India Pvt Ltd, Plot No. 27/B, 2nd Cross Road, Electronics City , Phase 1, Bangalore - 560 100, Karnataka, India.		
Prüfgrundlage: <i>Test specification:</i>	Customer's Requirement : Compression Deflection Test as per DIN 53577		
Prüfergebnis: <i>Test Result:</i>	Refer Page No.2 to 3

TEST RESULTS

Test Name: Compression Deflection Test

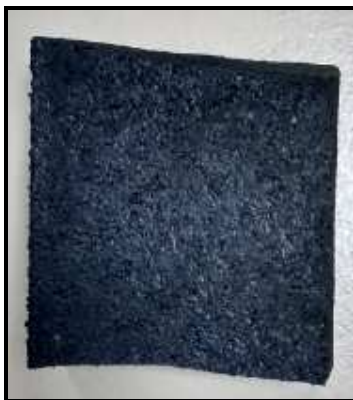
Sample Photograph as in Received Condition
