Prüfbericht - Nr.: <i>Test Report No.:</i>	IND/BLR/CH/2018/1500R	Seite 1 von 3 <i>Page 1 of 3</i>	
Auftraggeber: <i>Client:</i>	Sunflex Recycling Pvt Ltd Plot No. – 274/4, Shital Estate B/H Satyamev Complex, Opp. Gujrat High Court, S. G. Highway, Sola Ahmedabad, 380060, India		
Gegenstand der Prüfung: <i>Test item:</i>	RUBBER Tiles		
Bezeichnung: <i>Identification:</i>	Serien-Nr.: <i>Serial No./ Document Submitted:</i>		
Wareneingangs-Nr.: <i>Receipt No.:</i>	06032018	Eingangsdatum: <i>Date of receipt:</i>	06.03.2018
Order No.:	1803301976	Testing Period:	12.03.2018 to 18.03.2018
Prüfört: <i>Testing location:</i>	TÜV Rheinland India Pvt Ltd, Plot No. 27/B, 2nd Cross Road, Electronics City , Phase 1, Bangalore - 560 100, Karnataka, India.		
Prüfgrundlage: <i>Test specification:</i>	Customer's Requirement : Burning Behaviour Test as per FMVSS 302		
Prüfergebnis: <i>Test Result:</i>	Refer Page No.2 to 3

IND/BLR/CH/2018/1500R

Test Name: Burning Behaviour Test

Test Method: FMVSS 302

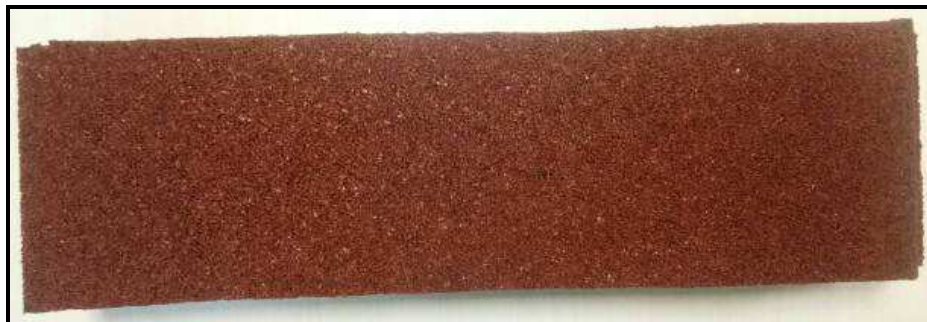
Sample Photograph as in Received Condition

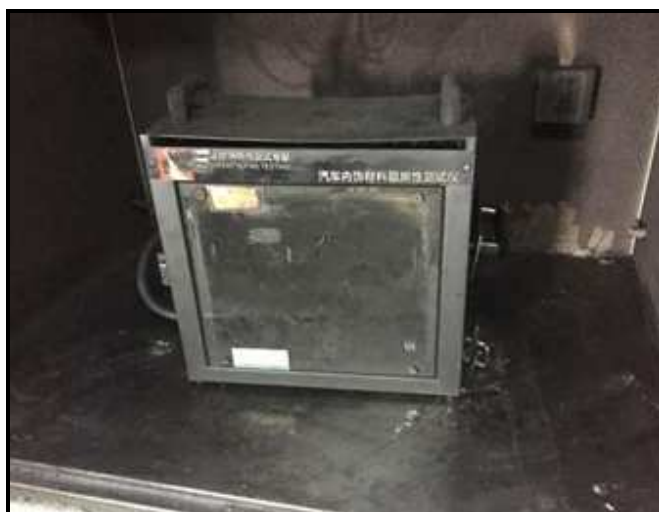
Test Conditions: Pre-Conditioning – At $23\pm 2^{\circ}\text{C}$, $50\pm 5\% \text{RH}$ for 24 hrs.
Lab Environmental condition - $23\pm 2^{\circ}\text{C}$, $50\pm 5\% \text{RH}$

Sample Photograph During Test

Sr. No.	Classification	Pass/Fail	Burning Rate(mm/min)
1	B	Pass	7.68
2	B	Pass	6.61
3	B	Pass	6.45
4	B	Pass	5.96
5	B	Pass	7.11
Average Burning Rate			6.8 mm/min

Conclusion: Tested sample meets the requirement of customer's specification.
